A Better Valve Poster

Exhaust Valve Failure Mode and Sequence Identification

By Dave Pasquale

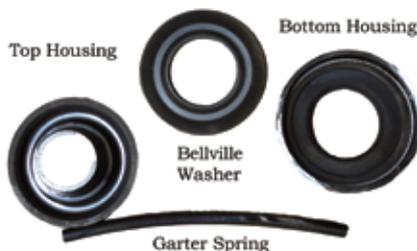
Valve Rotator Parts

The rotator shown is a garter spring type found in most Continental engines. Most uneven heat signatures occur when the rotator stops working. When the valve stops rotating, the wear is concentrated in one spot on the edge of the valve. This leads to reduced heat transfer into the cylinder head and a subsequent hot spot.
